Manhole Inspection Summary

Manhole # S23GG_004MH

Location Address: **1329 PRESSTMAN ST**

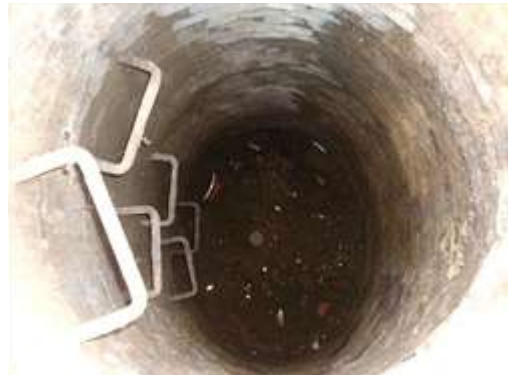
Top View

Channel debris

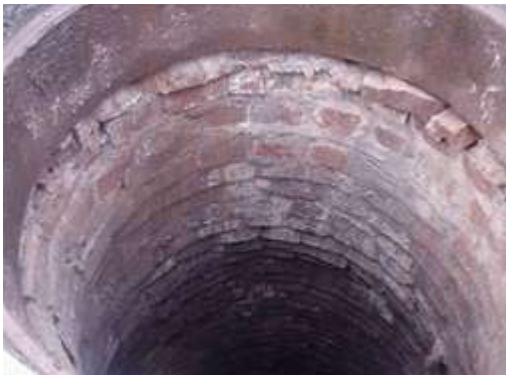
Defect

Frame leaks. Adjustment deterioration, loose brick and infiltration. Barrel infiltration - other side.

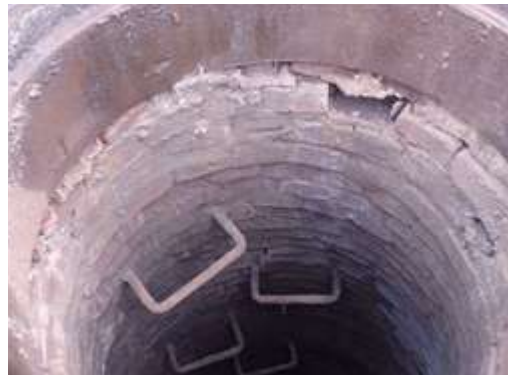
Defect

Frame leaks. Adjustment deterioration, loose brick and infiltration. Barrel infiltration.

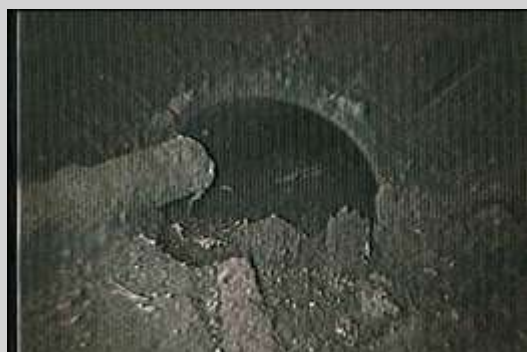
Pipe Out @ 12 O'Clock

Deposits: ☐ None ☒ **Mud** ☐ Sludge ☒ **Debris** ☐ Grease

Silt Depth: **3** (in.)

Deposits Extent: **Medium**
